**ANALYTICAL RESULTS REPORT
SITE INSPECTION**

CALMET

EPA ID # COD983767443

**U. S. ENVIRONMENTAL PROTECTION AGENCY
REGION VIII**

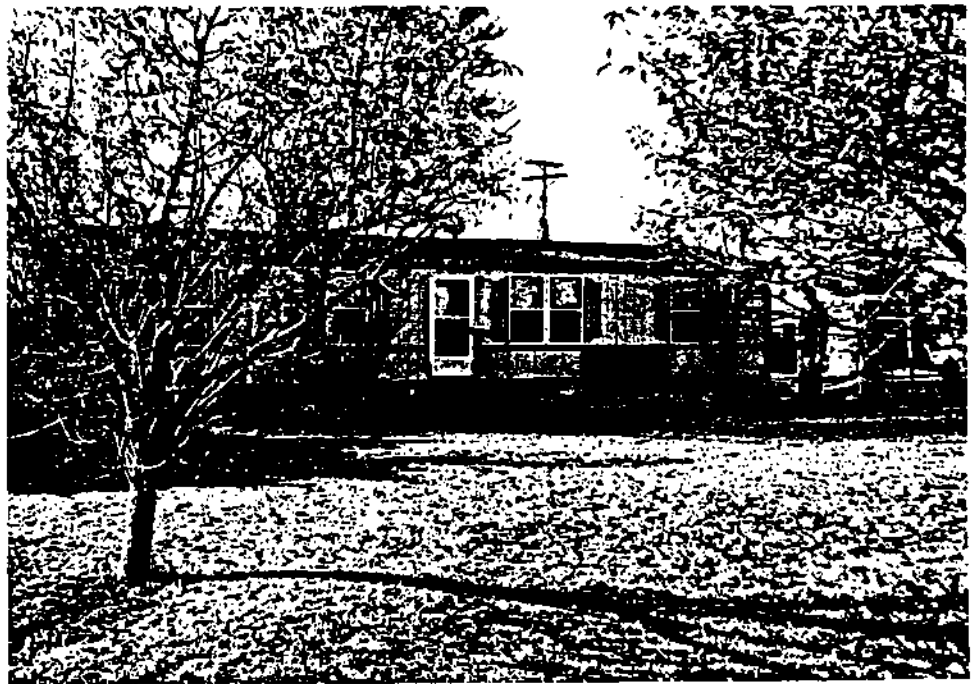
5

The Marshall Welding Shop and the Lengacher residence, located at 9060 Highway 85-87, obtain drinking water from a well located south of the welding shop. The wellhead, which lies in the basement of a wellhouse, is not protected by a cover. A submersible pump is held in the well by a rope tied to the floorboard above it (see Photos 2-4). Sample CA-GW-2 and CA-GW-3 (a duplicate) were collected from the kitchen tap in the residence (see Photo #5). Faucets in the welding shop were not sampled because of obvious solvent odors.

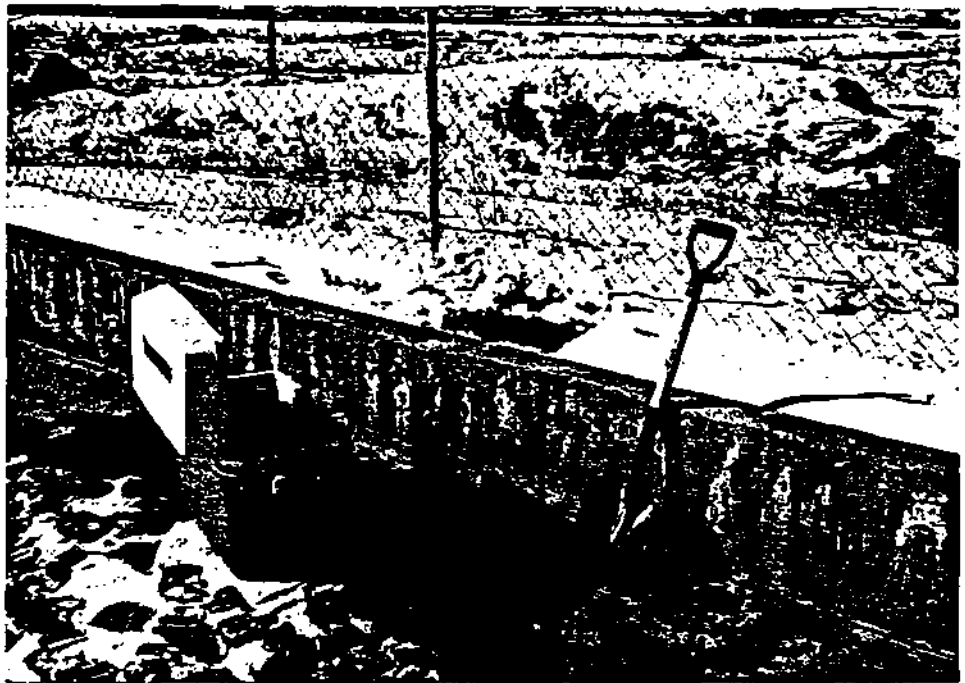
27

Sample CA-SO-2 was collected between the fence and berm wall of the tailings pad in the northwest corner of the site, not outside the fence at this location as specified in the SAP (see Photo #26). The soil at this location was coarse sand with some silt and pebbles. A dull greenish-blue stain was visible in the soil. CA-SO-3 was collected at a location slightly to the north of that shown in the SAP (see Photo #27). The soil at this location
